A Red Light Running (RLR) Photo Enforcement System was installed at the intersection of Lewis Avenue at Glen Flora Avenue on January 27, 2008 (southbound), after finding limited success with other attempted measures to promote safer driving and improve compliance with traffic laws. As a condition of use, both Illinois law and the Illinois Department of Transportation require periodic statistical analyses/evaluations be conducted.

Lewis Avenue at Glen Flora Avenue Waukegan, IL

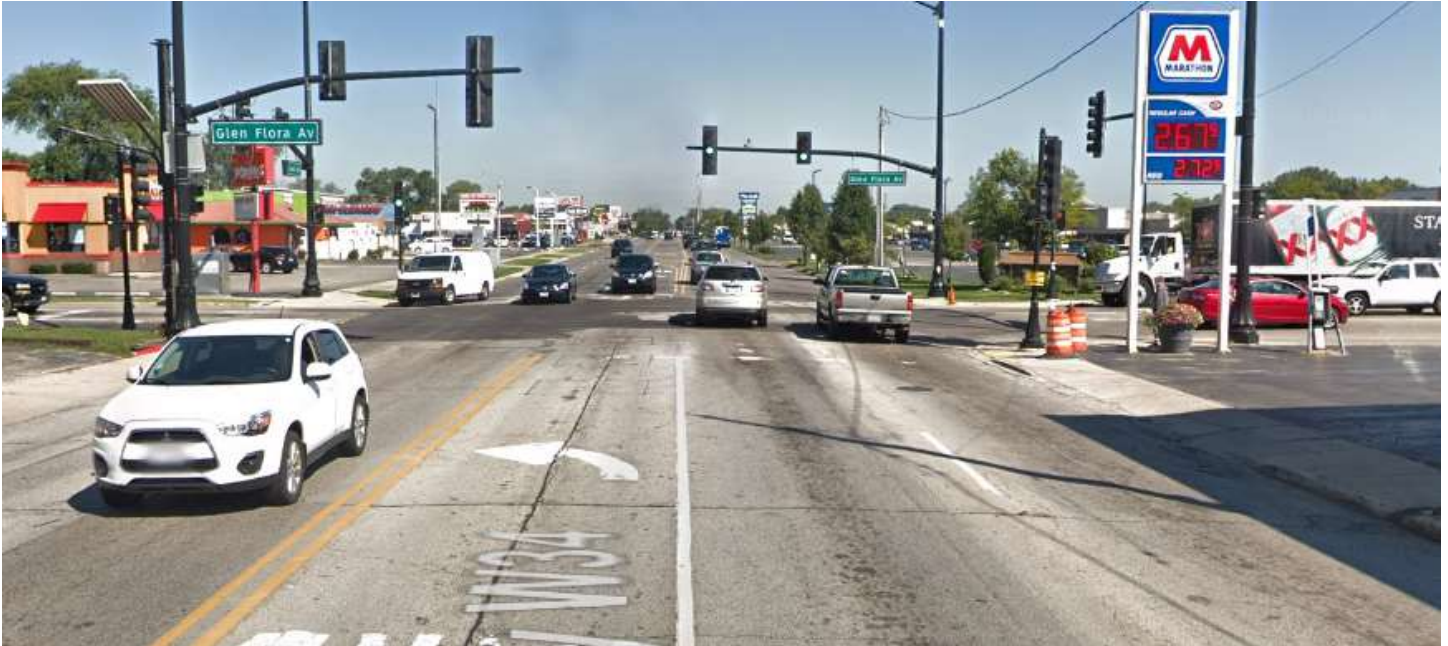
Lewis Avenue at Glen Flora Avenue, Northbound Approach

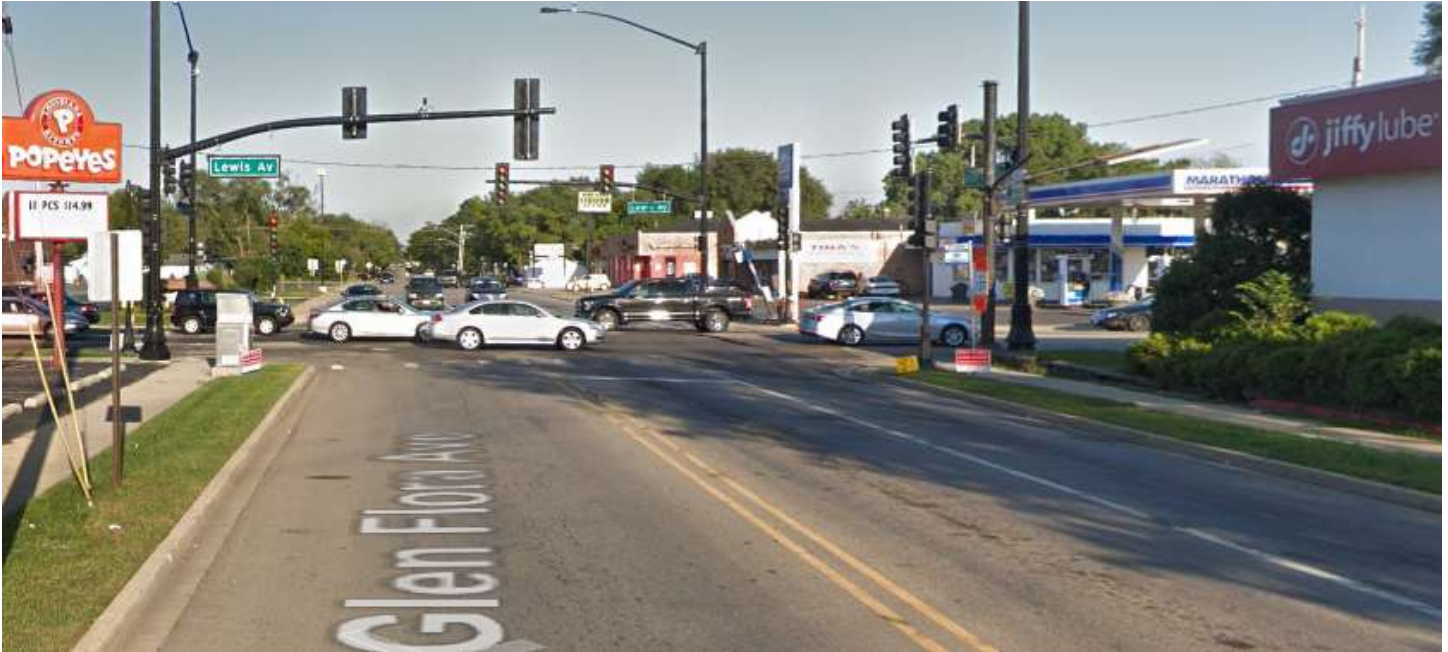
Lewis Avenue at Glen Flora Avenue, Eastbound Approach

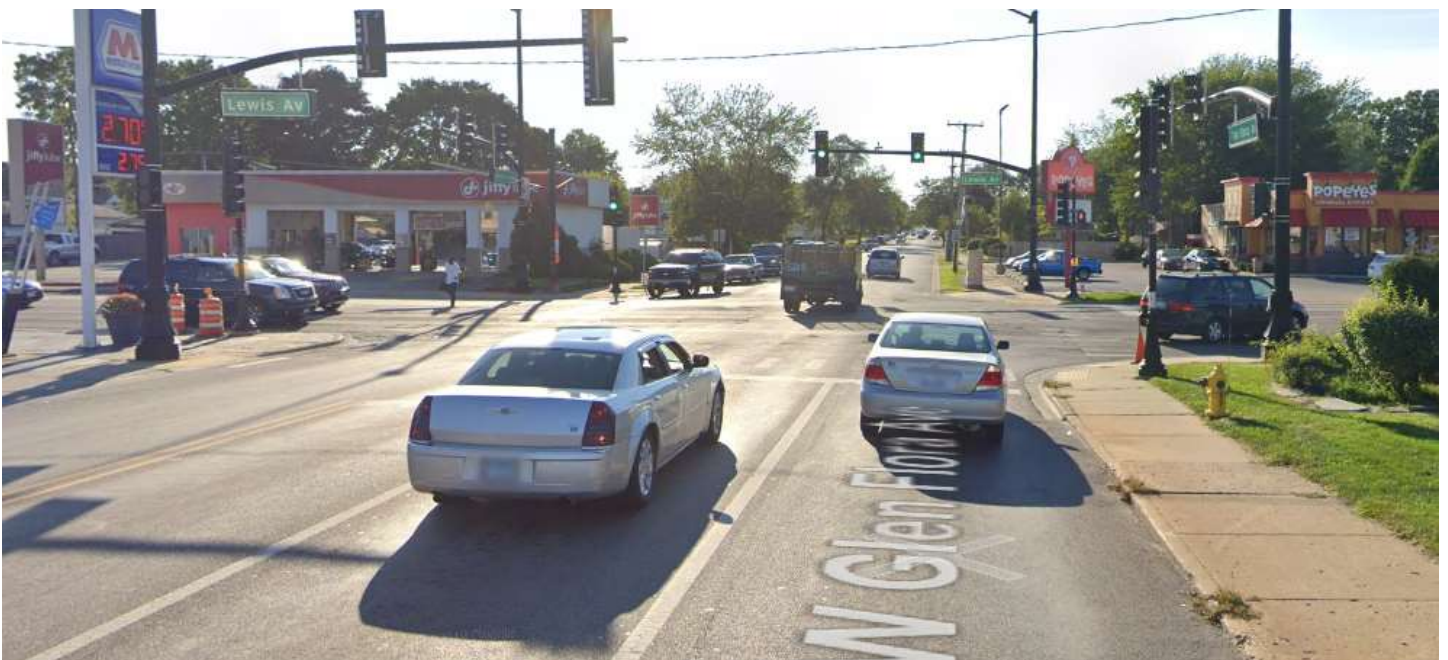
Lewis Avenue at Glen Flora Avenue, Westbound Approach
